Annual Inspection Report

Folsom Field

ANNUAL INSPECTION REPORT

FOLSOM FIELD CULLMAN, ALABAMA

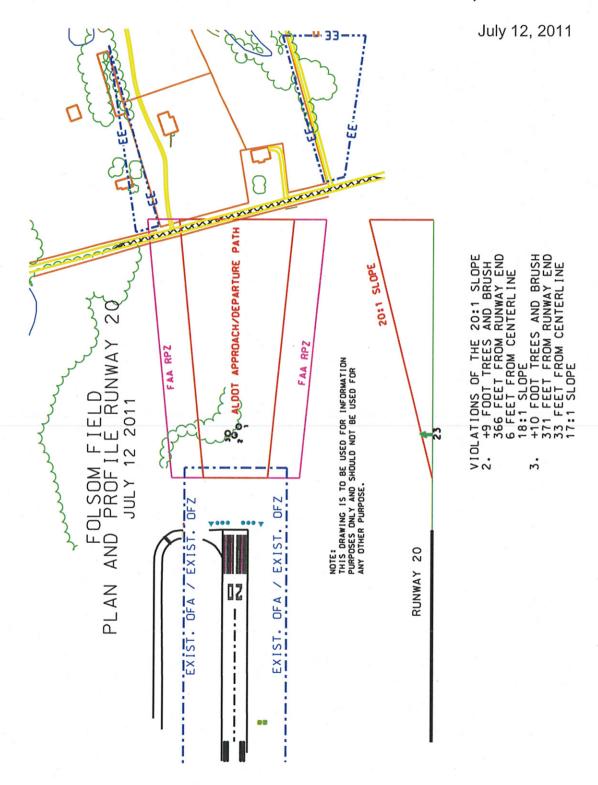
APPENDIX 1

→ Runway Safety Area (Appendix 1): All runways are required to maintain an obstruction free area adjacent to each runway. This area is 120 feet wide, centered on the runway centerline, and extends for a distance of 200 feet past the runway end. The area must be compacted and graded smooth with no ruts, humps, depressions or other potentially hazardous surface variations. The slope along the longitudinal centerline shall not exceed a rise or fall of three percent in elevation relative to the runway end elevation. The lip from the top of the pavement to the grade adjacent to the runway should not exceed 3 inches.

→ The Runway Safety Area was found to meet State licensing requirements.
